SAS Superstructure

Daily Diary Report by Bid Item

Diary #: 252 Const Calendar Day: 542 Date: 04-Mar-2011 Friday

04-0120F4
04-SF-80-13.2/13.9
Self-Anchored
Suspension Bridge

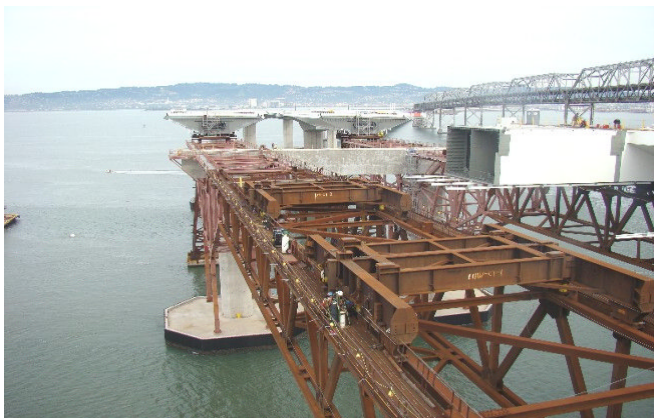
ABF surveyors seen at the E2 cap beam taking measurements for the two cradles for OBG Lift 11W.

- Began to observe and investigate the work being done on the two cradles for OBG lift 11W. Previous surveys indicate that the offset measured of the OBGs 10E/W from the centerline were approximately 50mm to the left of the E and W lines. ABF surveyors also measured comparable numbers. It appears that the cradles are being adjusted to compensate for this offset. Preparations are in the process of being made to check the offset for OBG lifts 11E/W due to this observation.

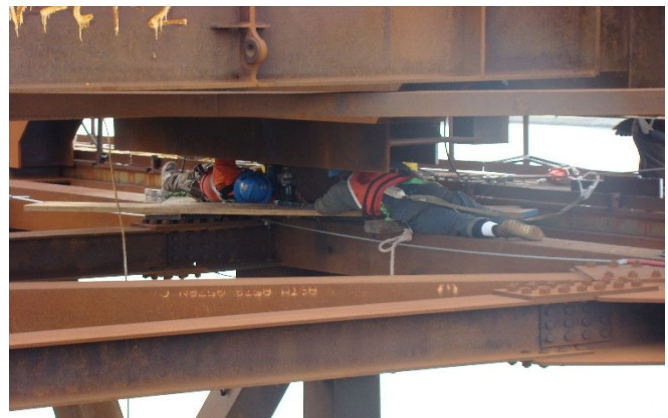
ABF ironworkers seen working underneath a cradle for OBG lift 11W.

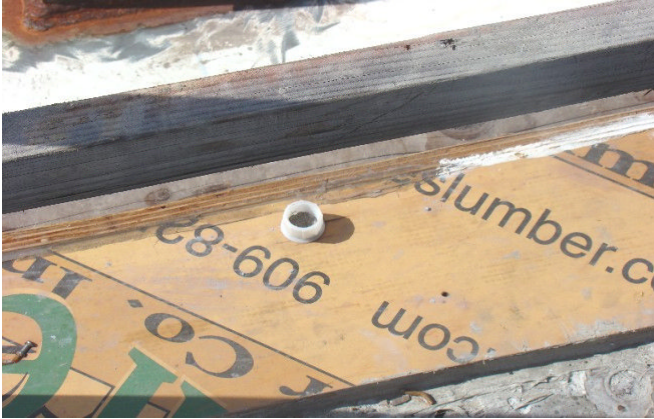
Grout seen at the holes used for the grout tubes at the top of the formwork of the W2W Hinge K pipe beam assembly grout pad.

- Met with Alex Schmitt to discuss the grouting operation for the Hinge K pipe beam assembly grout pads and the most representative testing schedule for the 36 grout cubes made.

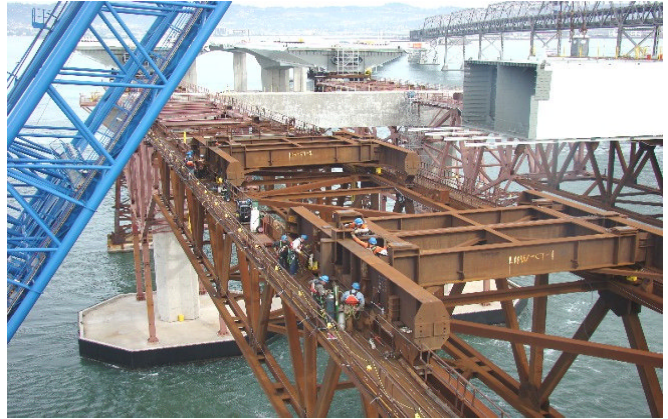
ABF ironworkers placing and reinforcing the two cradles for OBG lift 11W seen from the north end of OBG lift 10W.

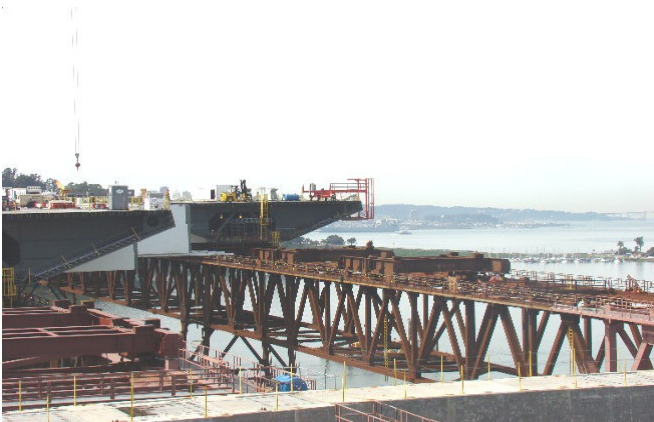
ABF ironworkers placing and reinforcing the two cradles for OBG lift 11W seen from the eastbound Skyway.

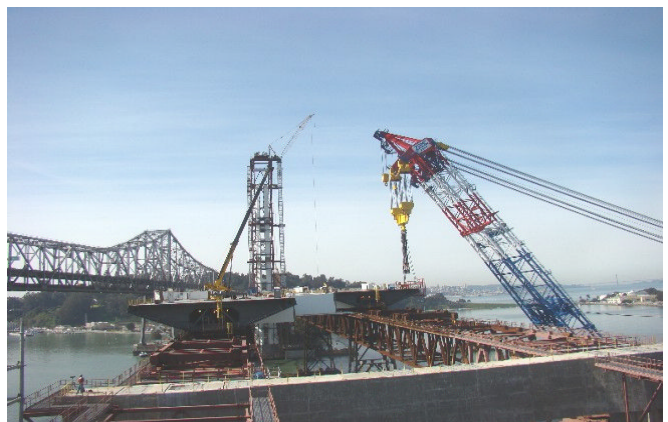
Left Coast Lifter preparing to remobilize to place the second crossbeam for OBG lift 11E after the first one was placed.
